**INSPECTION REPORT**

**Shaftesbury Town Hall**

October 2022

This report is based on findings of an inspection carried out on the **10<sup>th</sup> October 2022**. The weather was sunny and dry. For safety reasons, inspection at roof level was limited to the North roof slopes, and a view of the South from the fixed ladder at the West end of the roof. The report below includes recommendations for improved access in the future.

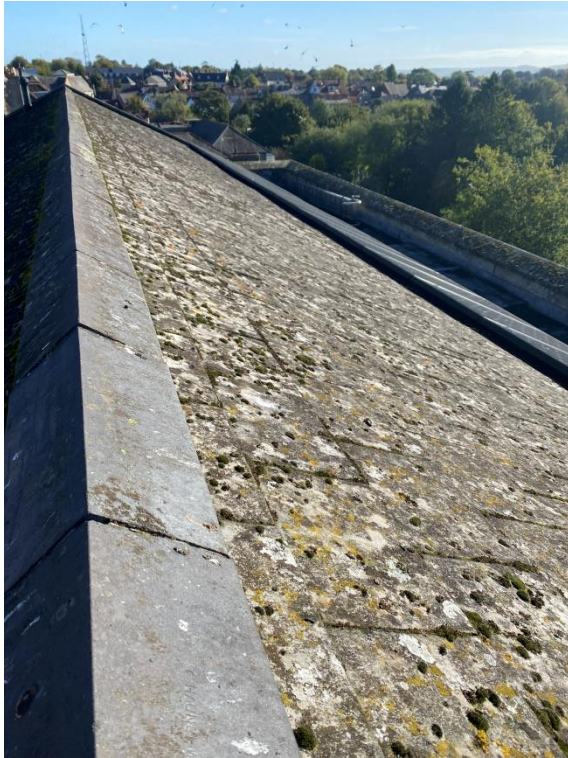
- 1.3 The current roof was constructed in the 60s and the asbestos slates date from this period. Life expectancy of asbestos slates at the time was thought to be 30 years, although there are many examples remaining 50+ years later. The slates on the Town Hall are, in the main, whole and intact, but lower corners are curling a little. Quite a number have broken around the clock tower and to lower courses of the North parapet gutter presumably where the roof has been accessed to install or maintain heating units. A replacement roof covering should be planned in the coming years.

1: South roof slope, Asbestos slates, ridge and PVs    2: Access ladder to south roof slope, loose flashing

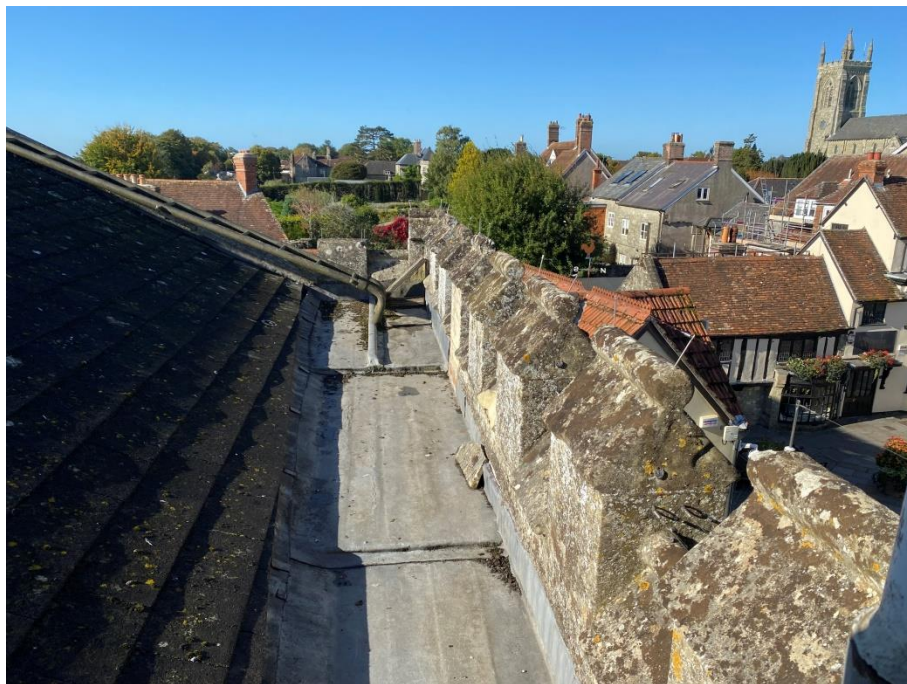
- 1.11 The North parapet wall is castellated with stone merlons terminating with a roll top. There is one fractured stone to the West of the clock tower with the lower portion sitting in the gutter. This could be pinned and adhered back in position. The one missing merlon to the West return is currently sitting behind the clock mechanism in the tower.

3: North West lead lined gutter, fractured stone (RHS) missing merlon

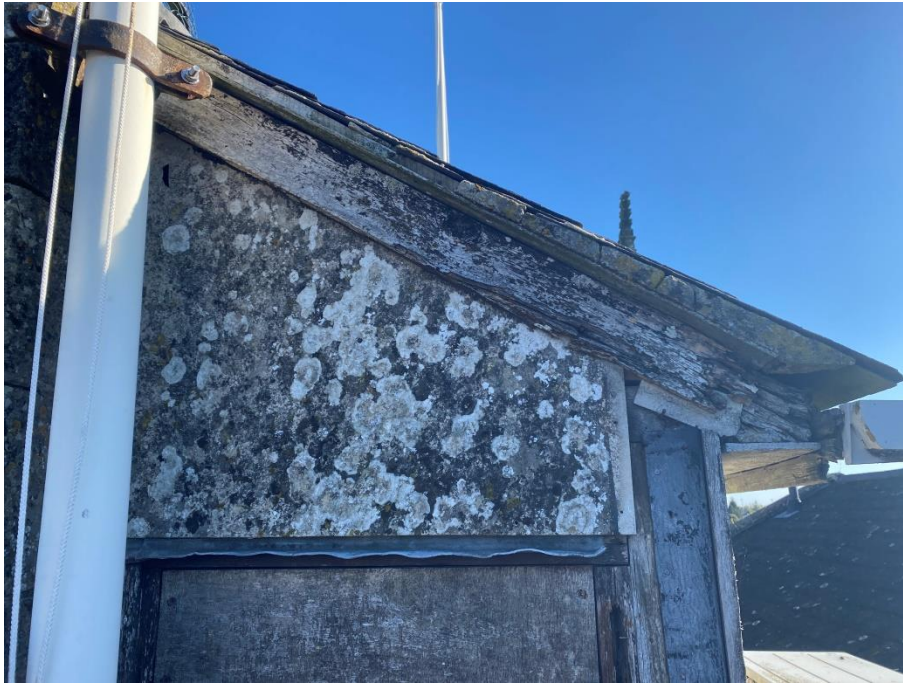
- 1.19 The South side of the clock tower is timber framed with asbestos cement sheet cladding. The whole timber structure is in poor condition and cladding sheets are fixed with nails which are now rusting. Cover boards are missing to the corners exposing the rotting timber studs behind. The short barge boards to the slate section of roof have rotted through, and verge pointing has failed. Condensing units for the air conditioners have been fixed through the asbestos sheeting to plywood linings. Access doors to either side of the structure onto the roof are also simple sheets of ply which are delaminating (NB noted as ledged and boarded in the 2009 report). In short, the existing could be patched, but I would recommend substantial replacement of the structure with more robust construction when funds permit.

4: Asbestos clad clock room, rotten barge boards, missing cover board

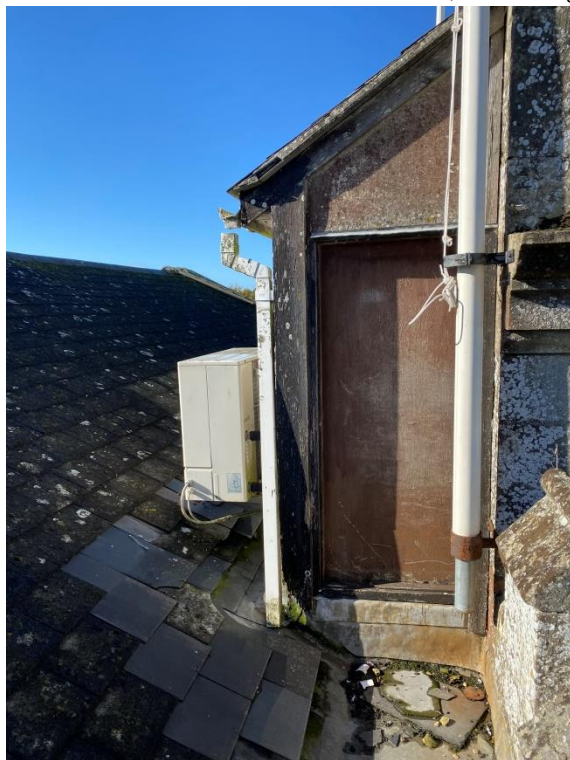
- 1.9 There are a significant number of broken slates where the clock tower interrupts the North roof slope, some of which have been replaced with fibre-cement (non-

5: Ply door to clock room, replaced/broken slates, gutter remote from downpipe.

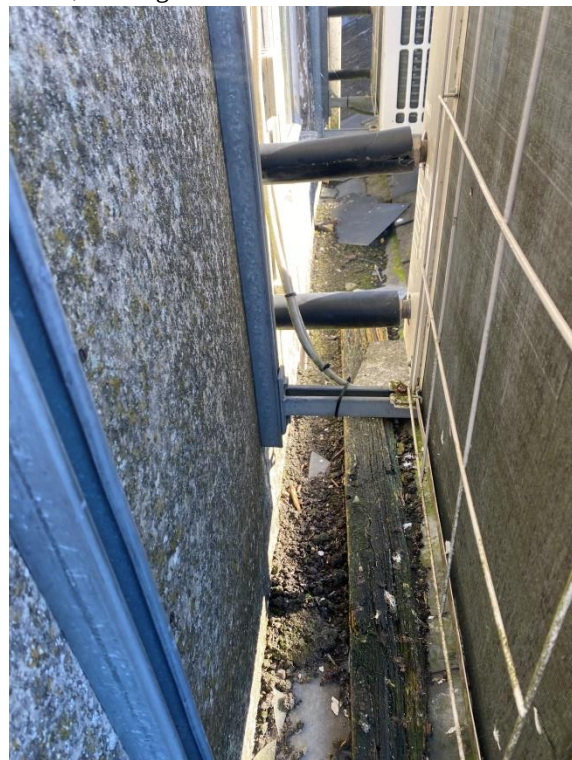
- 1.10 There are a number of creases and one split in the lead gutter to the West of the clock tower which should be patch repaired. Steps are very shallow, and whilst laps appear to be good, would offer little resistance to water ingress if the gutter backed up. There is currently a loose strip of lead with lead clips running beneath the bottom course of slates, perhaps intended as an under-eaves course, but detached and currently serving no purpose. Cover flashings to gutters both East and West of the clock tower are generally intact, but have a few gaps in the pointing where tucked into the parapet.

6: Gutter behind clock tower

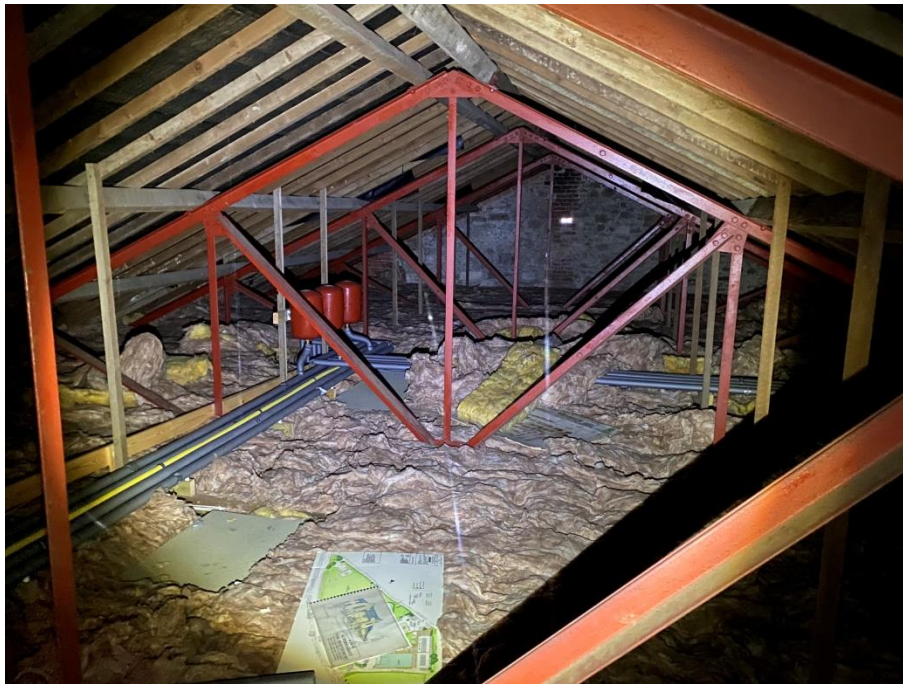
6: Roof space showing steel trusses, irregular untidy insulation, expansion vessels

5.5.1 There is a water stain and cracking to the plaster immediately over the office door borrowed light. This is likely to be associated with the expansion vessels in the roof void over which should be checked (*see 2.9 and photo 6 above*).

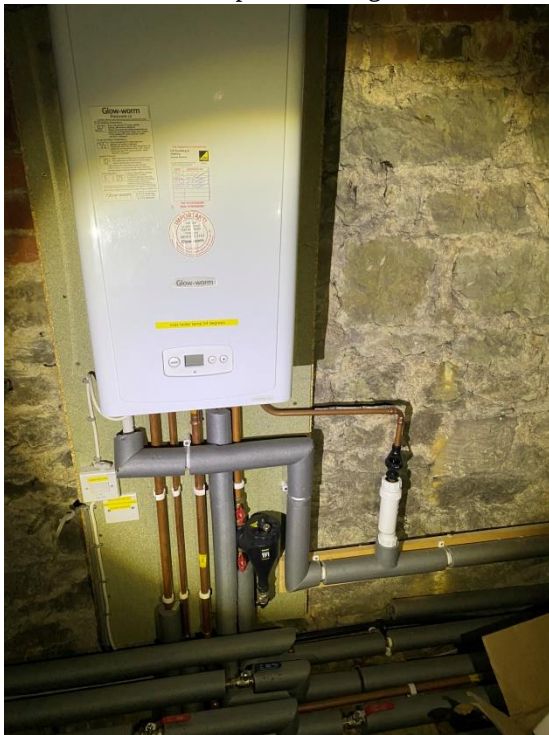
- 2.9 There is a Glow-worm Flexicom cx combi boiler located on the East gable. This sits above insulation in cold conditions. Whilst the majority of pipes are lagged, the majority of those rising to the boiler are bare, and vulnerable. Pipes crossing the roof void run to expansion vessels located centrally, and on to the external condensing units to the South side of the clock tower.

7: Boiler within roof space – uninsulated pipes

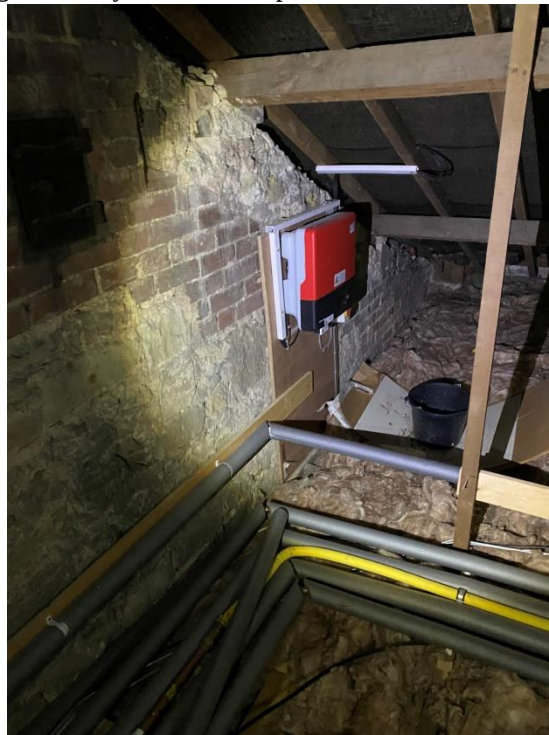
- 2.10 Since the 2009 report, a single line of PV panels has been installed to the South roof slope. The inverter for these is also mounted on the East gable. There is currently a bucket beneath the point where cables pass through the roof finishes at the East end of the panels, presumably due to leaks.

8: PV inverter with bucket beneath roof penetration

5.5.2 There is similar staining and cracked plaster over the stairs immediately below the PV panel entry and bucket (*see 2.10 and photo 8*).

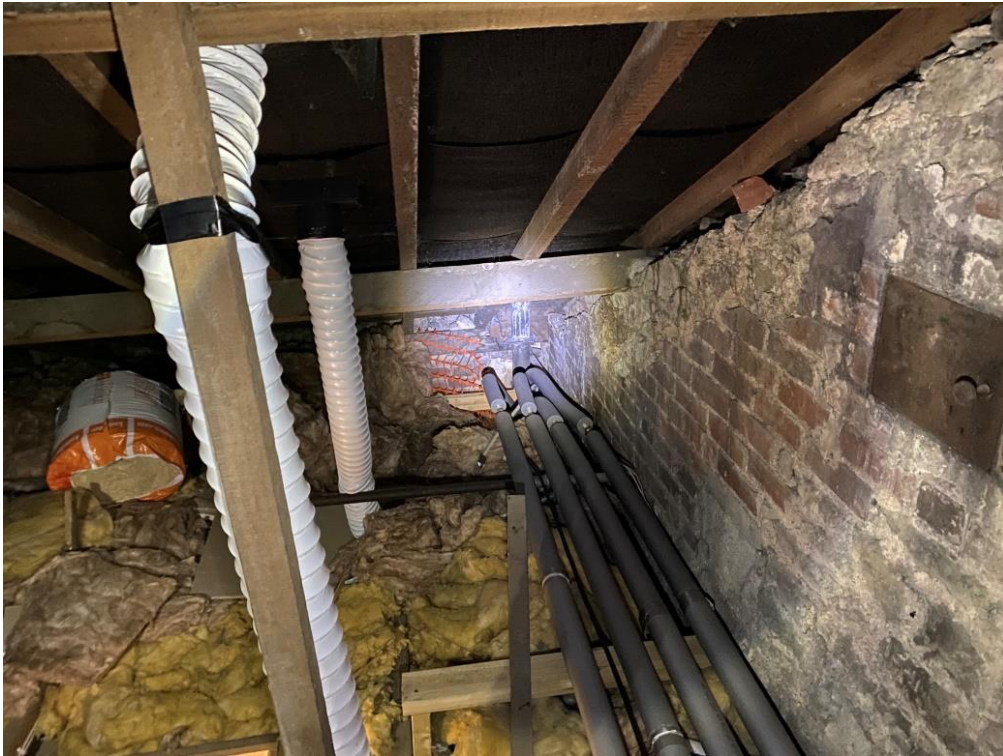
9: North East corner redundant lead soil stack, w.c. extract ducting, roll of unused insulation

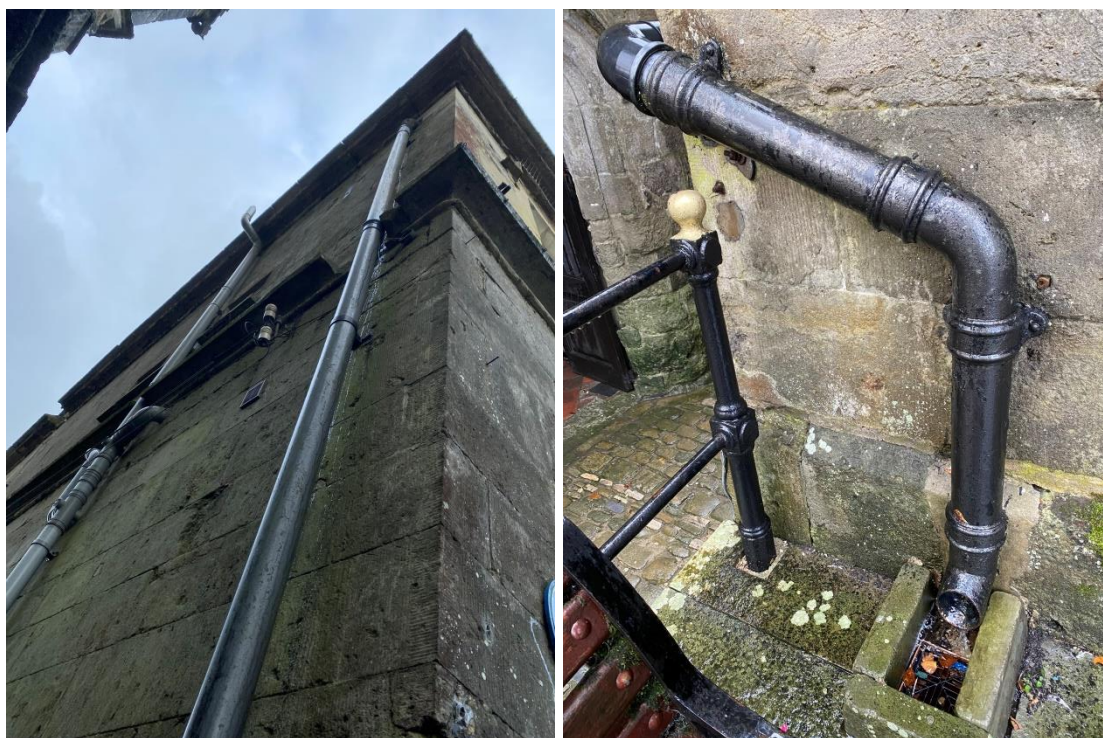
- 3.2 The North Parapet to the East of the clock tower discharges through the West elevation in what appears to be a lead pipe which is crudely jointed to a 100mm dia plastic downpipe. This turns around the North West corner of the building with plastic fittings approx. 1m above ground level and connects into the last section of cast iron pipe. The cast iron downpipe has a shoe discharging low into a trapped gully. I noted that a trickle of water was running down the wall behind the downpipe emanating from the top – possibly where lead is connected to plastic. Consideration might be given to altering the gutter outlet to the North elevation with similar detailing to the South outlets (thereby avoiding the awkward turning of the corner at the lower end).

10: Plastic downpipe to NW corner wall damp behind 11: Last cast iron section and shoe into gully

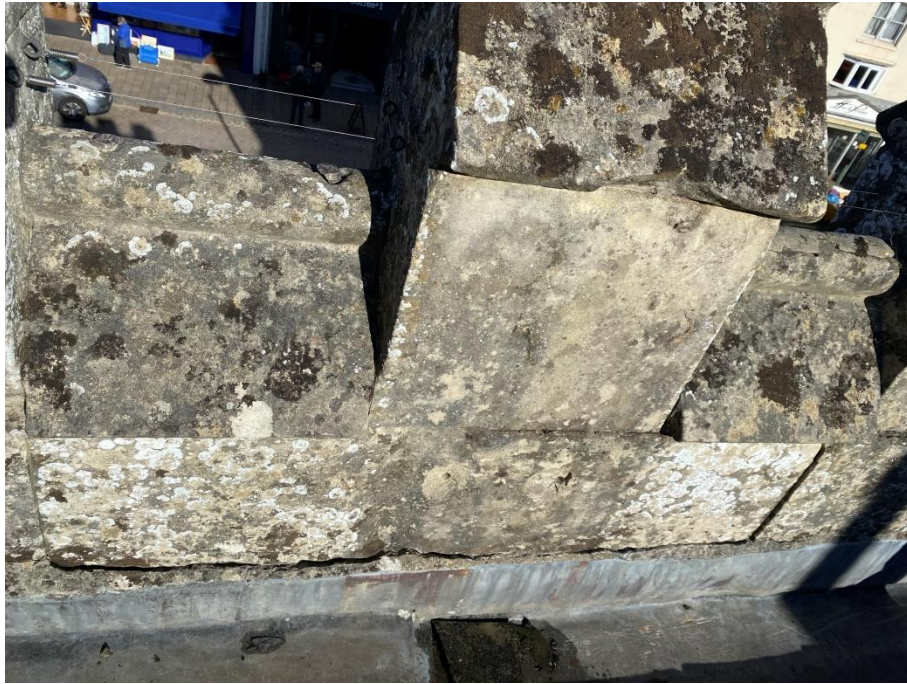
- 4.3.3 One merlon to the West of the clock tower has a section of sheered stone (where the flagpole was previously fitted) and should be pinned and mortar repaired.

12: Stone block to parapet out of place (where flagpole previously fitted)

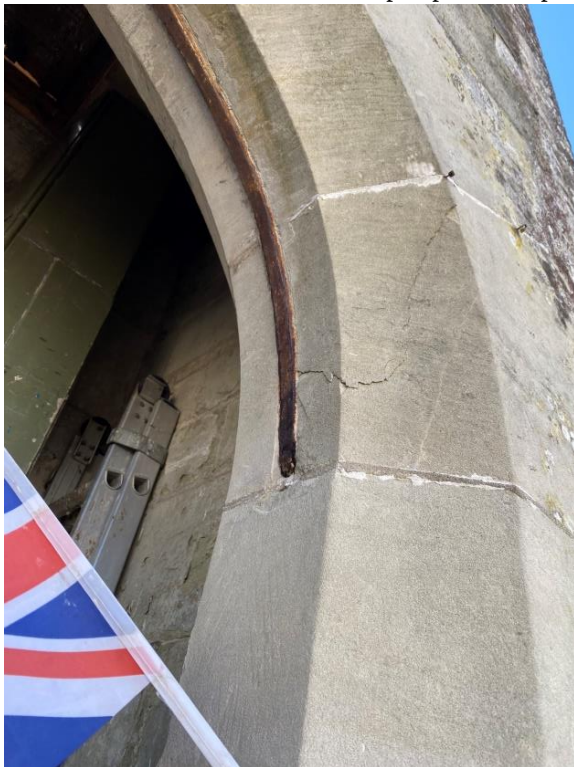
- 4.3.9 The arched openings to the porch and first floor clock tower are tied using ferrous metal straps set into their under-side. All have corroded to some degree, the worst being beneath the clock tower, where expansion of the metal caused by corrosion has blown the adjacent stones. Replacement with non-ferrous equivalent would be ideal, but removal of the rust and decoration may arrest the damage in the short term. – *see photo 13*.

13: Corroded strap beneath clock tower arch

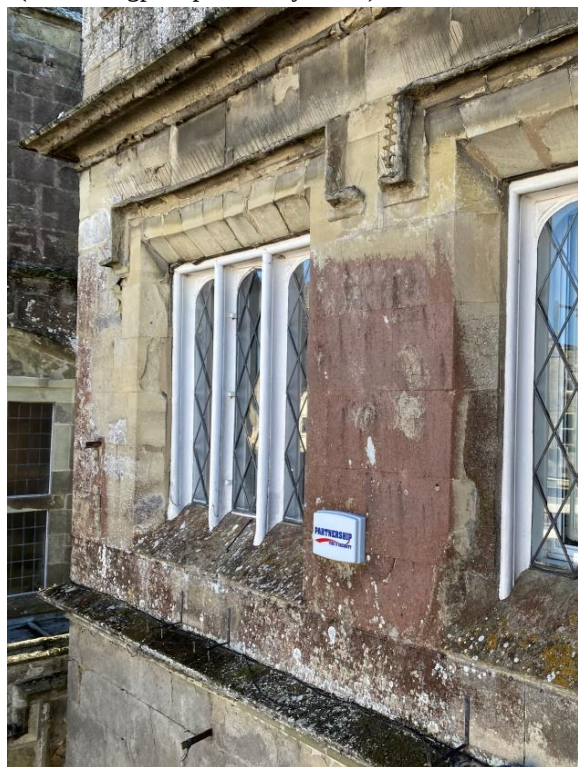
- 4.3.8 Mortar repairs and pointing between the window frame and stonework to the first floor window to the East, is fractured and working loose. Situated above the entrance door to the council offices, it would be wise to remove any loose segments to prevent falls. Some further pointing/repair will be required. – *see photo 14*.

14: North East corner scaling and previous mortar repairs

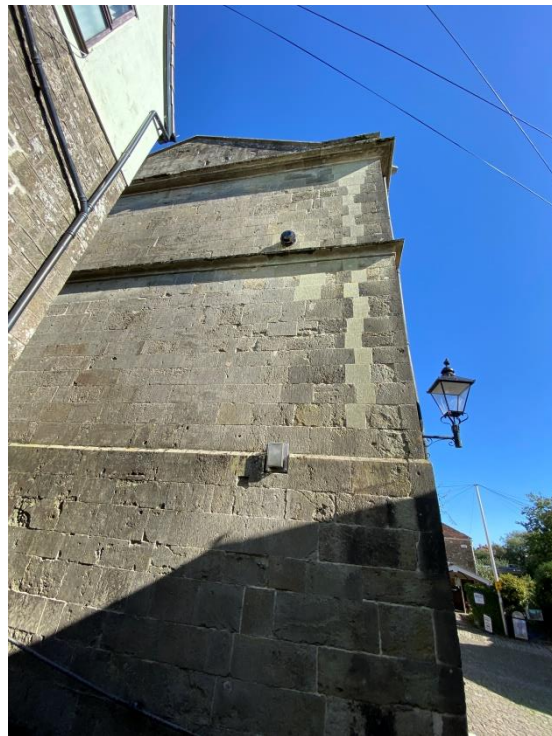
4.4.5 There is some recent stone replacement at the South corner where the downpipe has been relocated to the South elevation. New stone faces have been tooled to match existing.

16: South West corner showing previous stone replacement

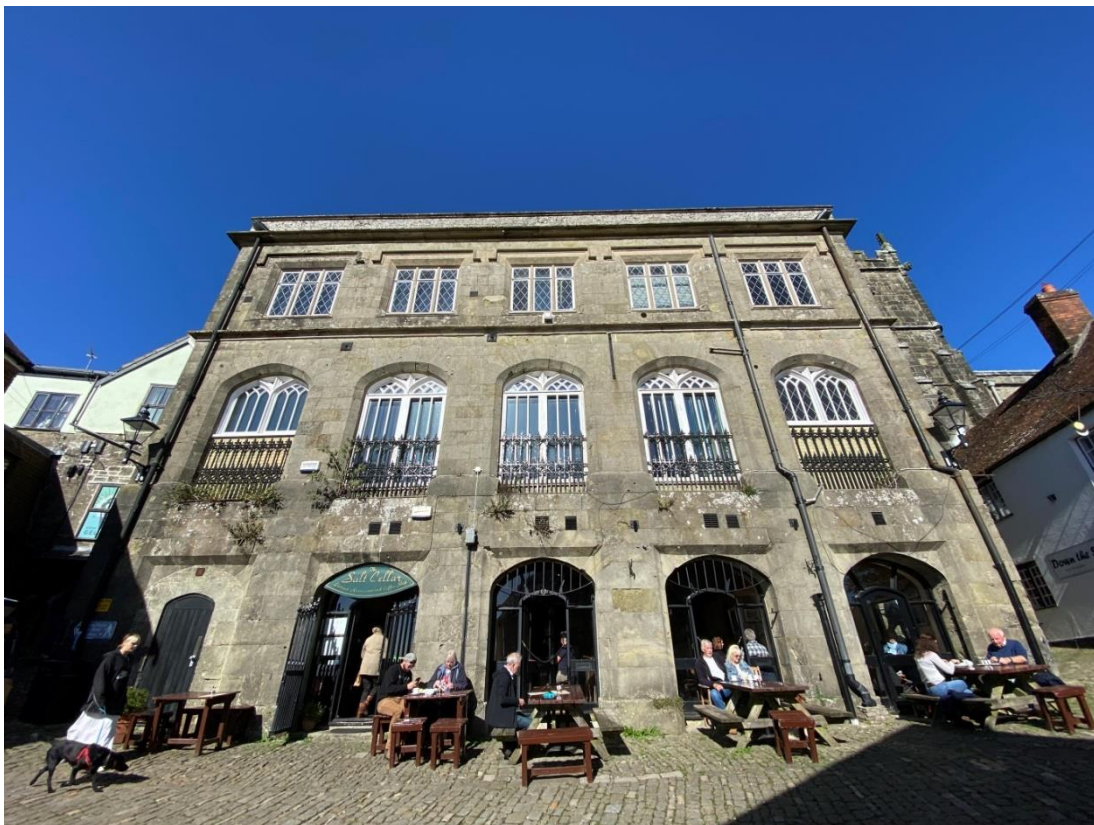
17. General view of South elevation. Plant growth, ties, vents and services.

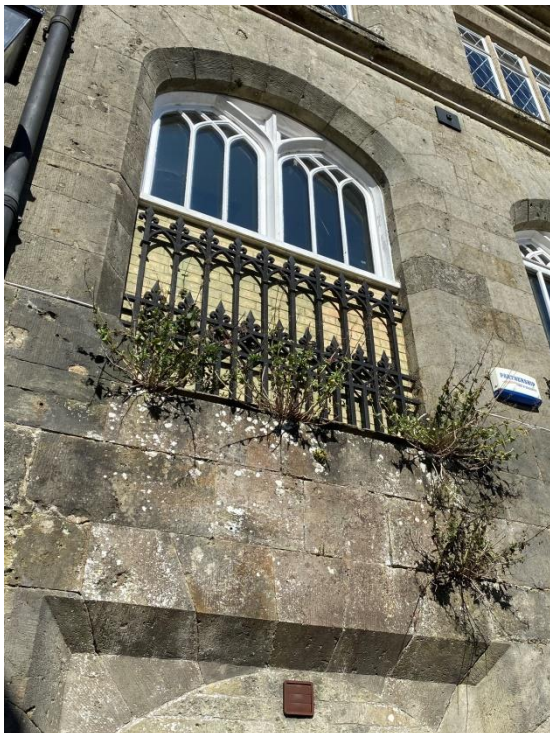
18: painted brickwork railings and vegetation

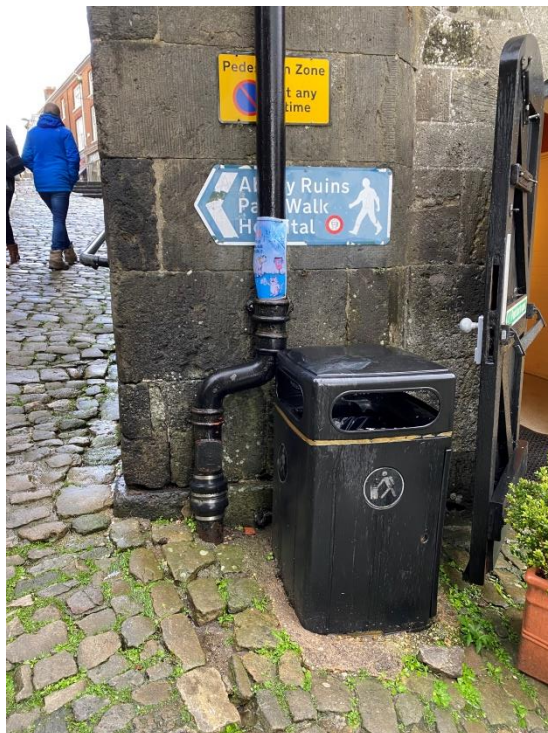
19: South West corner showing signage rwdp etc.

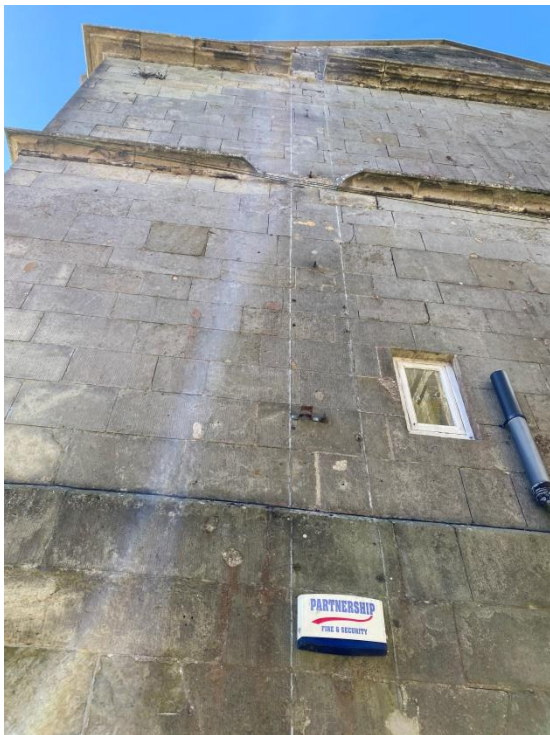
20: Scar from removal of flue

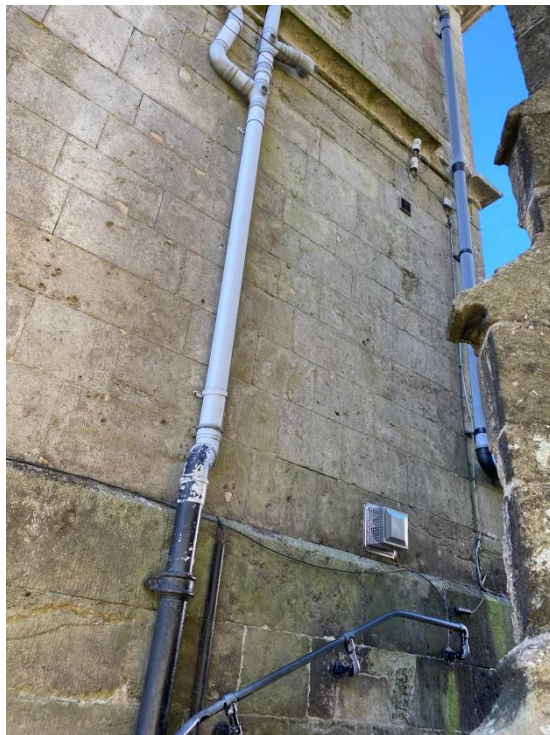
- 4.6.4 To the North end of the wall, a grey plastic soil pipe with external branches and wastes serves the first floor w.c.s. This drops into black cast iron for the bottom stage. Ideally this should be internalised, or replaced with cast iron. The rainwater downpipe to the North corner is also plastic - *see 3.2. and photos 11 and 21.*

21: Plastic pipes close to North East corner

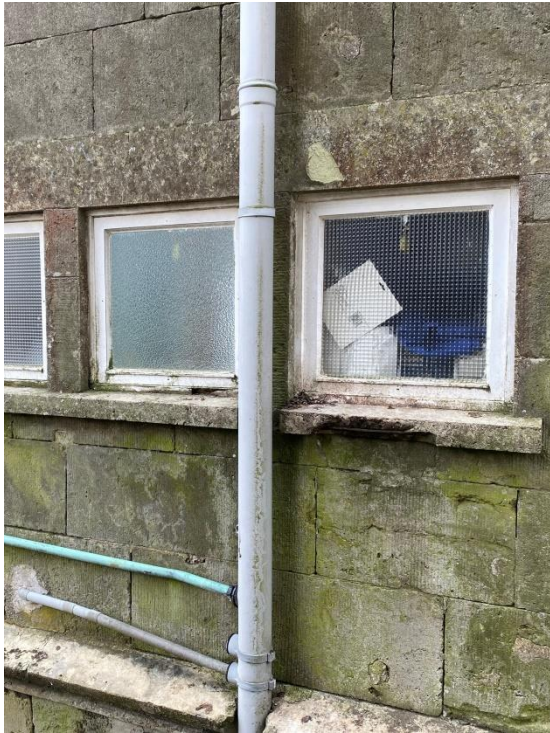
- 4.6.5 The cast sill beneath the three w.c. windows has blown exposing the corroding reinforcement. Other sections may also be corroding – *see photo 22.*

22: Blown window cill to w.c.s

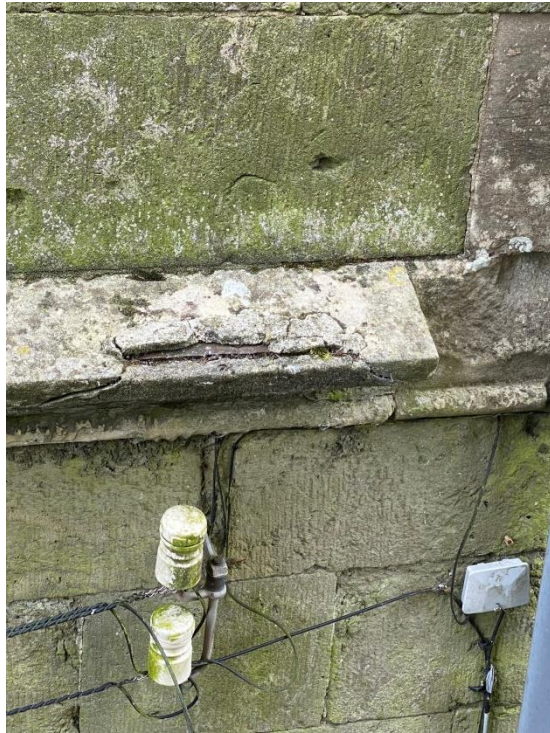
- 4.6.6 An old mortar repair to the string course beneath the w.c. window has also failed revealing the corroding armature. I would recommend that this section of mortar is checked at close quarters and any loose sections removed without delay.

23: Failing mortar repair to string course NE corner.

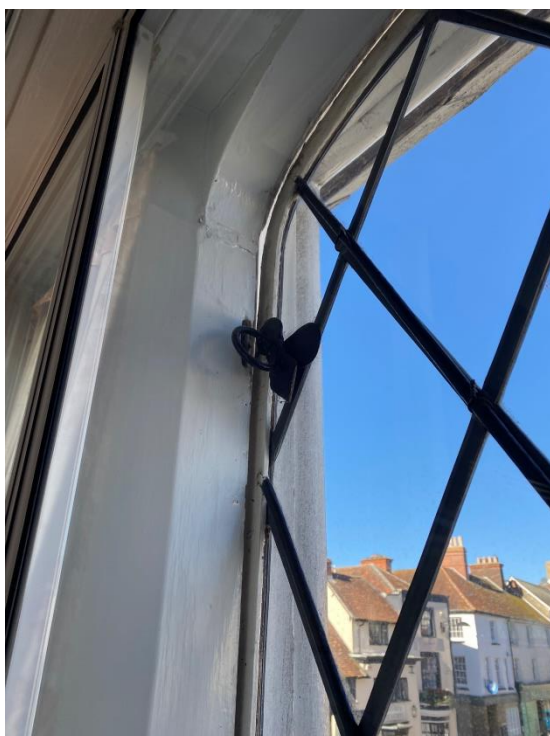
- 5.1 Windows to the North are timber frame, with metal sash leaded casements all with arched heads. Unfortunately frames have come apart at the corners, and casements have dropped preventing the windows from closing fully. Decorations are flaking and peeling to the frames generally. Opening lights rely on external pin hinges, some of which are corroding. Secondary glazing is fitted, but has been removed (for cleaning?) in the past and re-assembled in the wrong order, with draught stripping now on the face rather than between sliding casements. The condition is the same to all North windows of the first floor.
- 5.2 Windows to the South are Crittal style metal casements within cast frames. *See 4.5.5 above for condition.* Secondary glazing is in a similar condition to the North windows.

24: Ill-fitting leaded casements to North windows

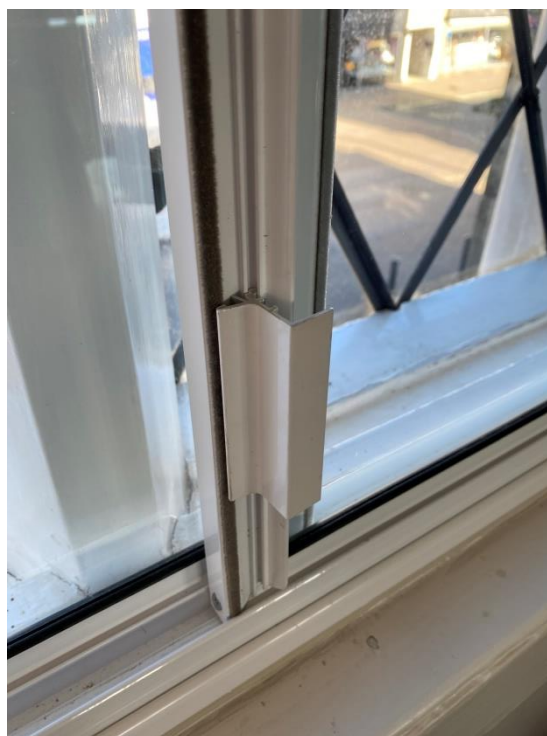
25: Incorrectly assembled secondary glazing.

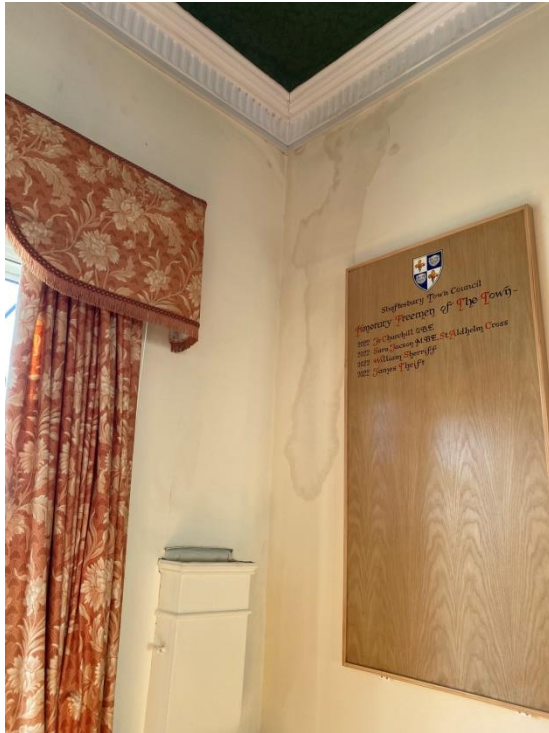
- 5.3.2 Staining is evident to high level in both the North East corner and the South West corners of the room. This corresponds with parapet gutter outlets over. At the time of inspection, gutters and downpipes were clear and operating well, so the staining may be historic. However the cover flashings are loose to the South West corner (see 1.8 above), which may still contribute and be ongoing.

26: Staining to the SW corner of the chamber

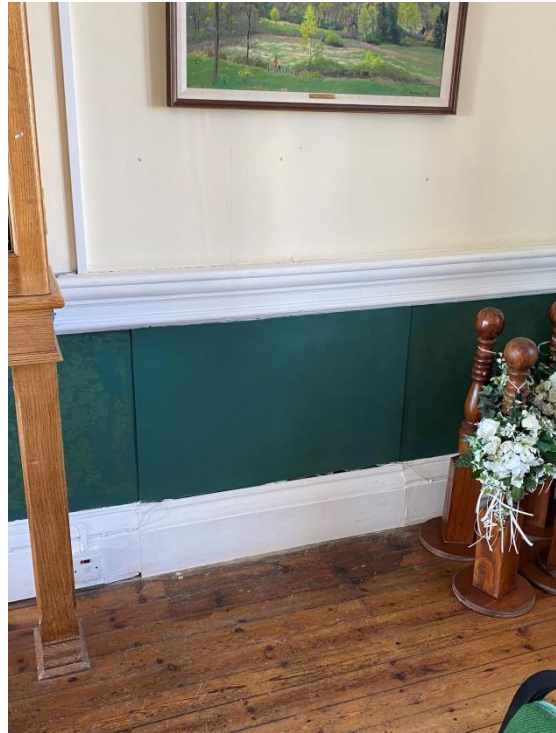
- 5.3.4 Gas heaters have been removed from the West elevation and exposed internal finishes have been vaguely matched over boards beneath the dado rails. External flues remain behind (*see 4.4.4*). It would be desirable to remove the flues and complete making good and decorations to a higher standard. This is common throughout the building where gas heaters have been removed. There is some interesting surface wiring to the skirting line.

27: Patched wall where gas heater has been removed

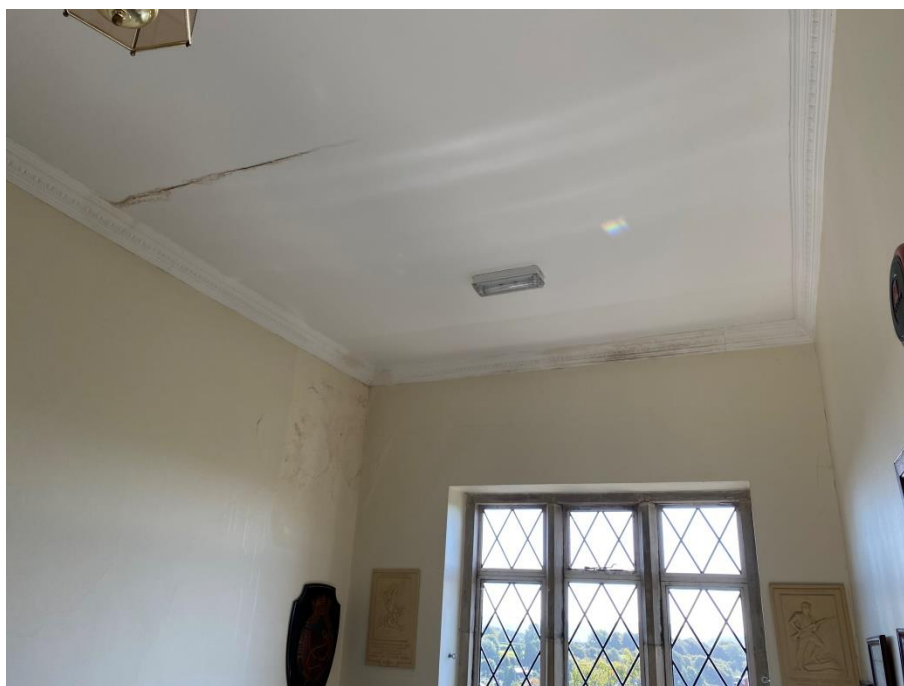
5.5.3 There is a significant stain to the South East corner of the stair landing and along the cornice. This could not be checked at close quarters, but sits beneath the parapet gutter outlet which has been re-routed. It may be historic, but without close inspection is impossible to confirm. Some white staining of felt in the roof space over remains

28: Stains and cracks to ceiling over stair case, and landing (including stains to cornice)

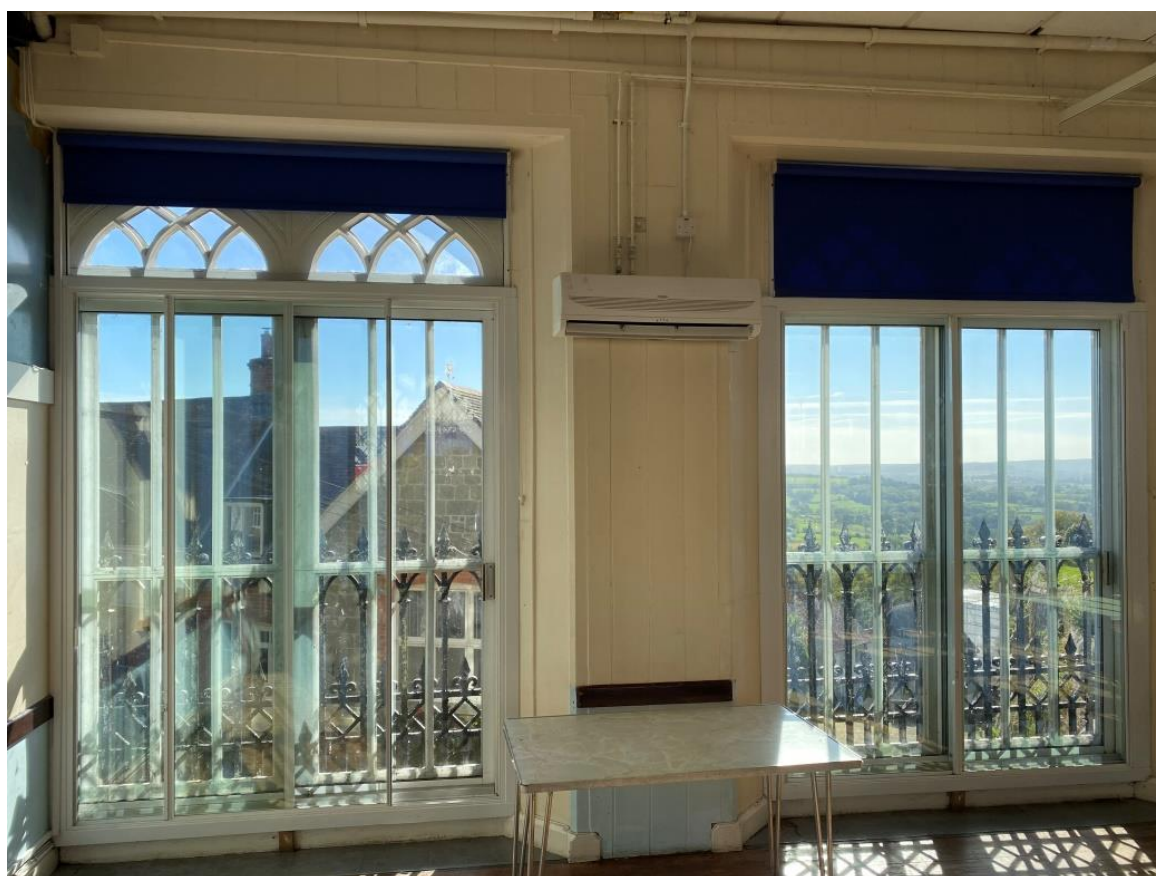
30: Barrier to the views by railings, timber frame, patio doors and secondary glazing

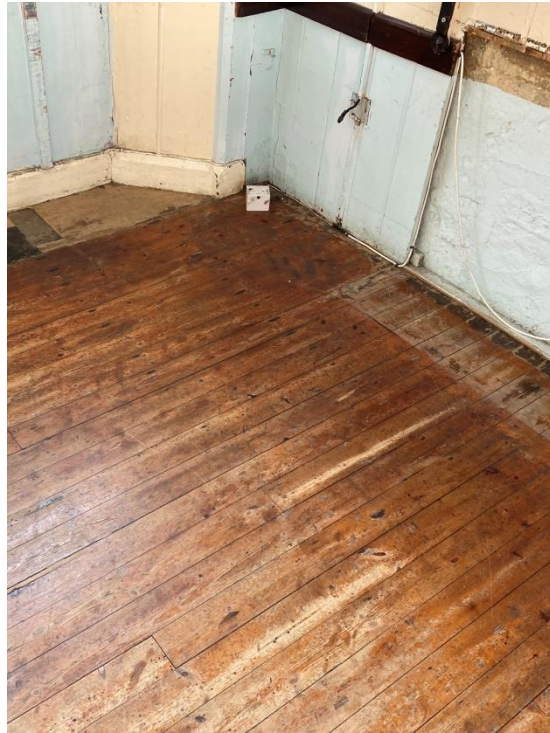
32: various floor finishes, patched walls, wiring SW
